# EVALUATION OF STABILITY OF DUMP SLOPES THROUGH OBSERVATIONAL AND NUMERICAL MODEL APPROACH – CASE STUDY

## ABSTRACT

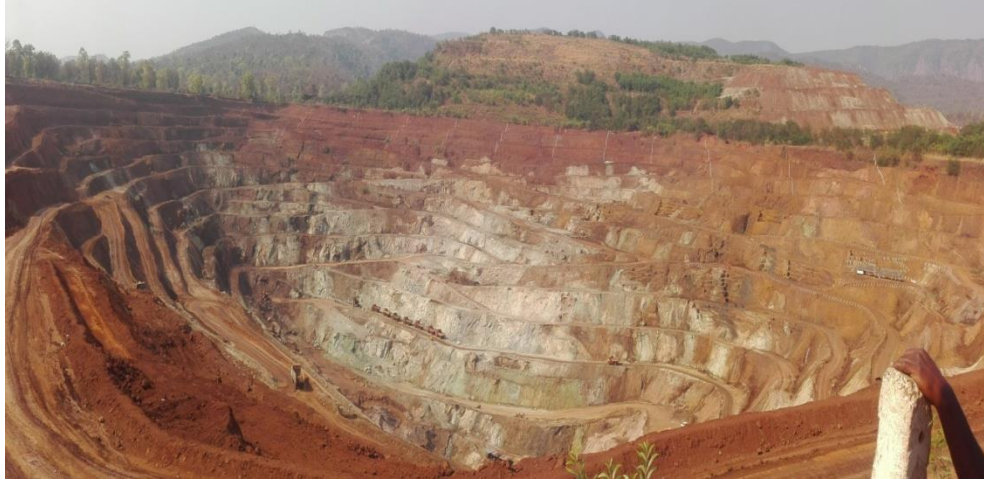
**Fig.1. Condition of the workings on June 9, 2017 in a typical chromite mine**

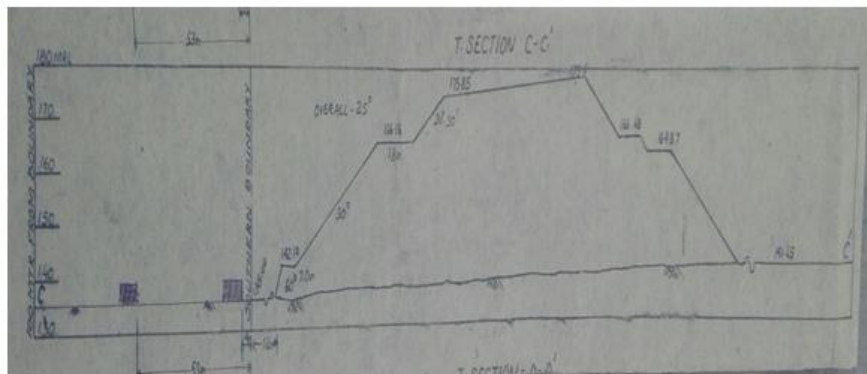
Figure 4 shows the Section of the south dump along the CC'. Figure 5 shows the Simulation output of the south dump along the CC' Section using FLAC Slope with FOS of 2.49 indicating stability of dump. Figure 6 shows the Section of the North dump along the 3000E. Figure 7 shows the Simulation output of the North dump along the 3000E Section using FLAC with FOS of 1.15 indicating stability of dump.

**Fig.4. Section of the south dump along the CC'**

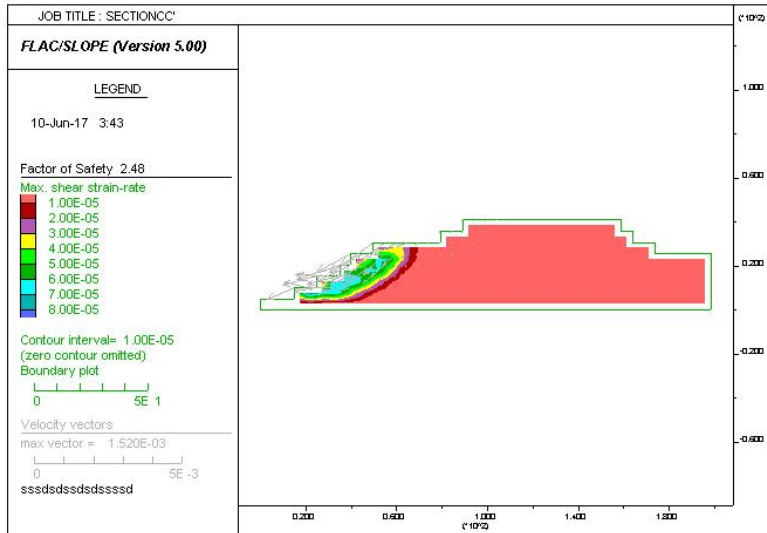
**Fig.5. Simulation of the south dump along the CC' Section using FLAC Slope.**

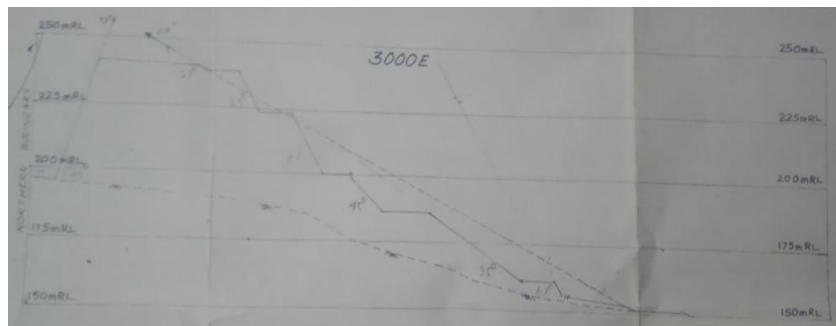
**Fig.6. Section of the North dump 3000E**

Based on above analysis, the FOS achieved for the three vertical Sections 2800E, 2900E, 3000E and one horizontal section 3300N for the North dump was 1.42, 1.28, 1.15 and 1.47, respectively indicating the stability of dumps in drained condition of slopes. Similarly, the FOS reached for the three vertical Sections AA', BB', CC' and one horizontal section H-H' for the North dump was 6.81, 1.41, 2.49, and 2.67, respectively indicating the stability of dumps in drained condition of slopes. In saturated condition of slope, there is a possibility of reduction of FOS, which may lead to failure of slope, and hence proper drainage is highly solicited. As the FOS for the vertical Section 3000E for the North dump was 1.15, efforts may be made to regrade the dump, accordingly to minimize the any scope of further reduction of FOS.

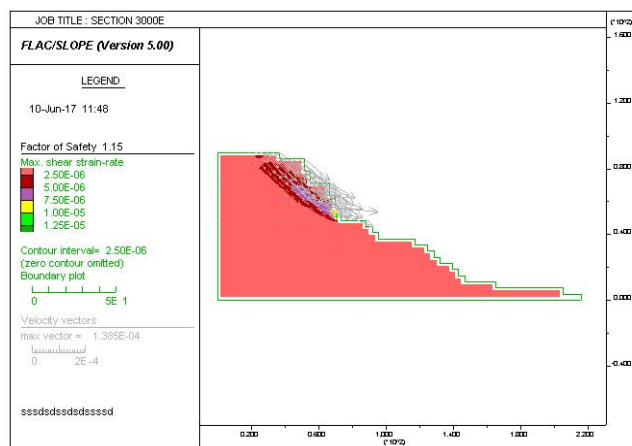
**Fig.7. Simulation of the North dump along the 3000E Section using FLAC Slope**

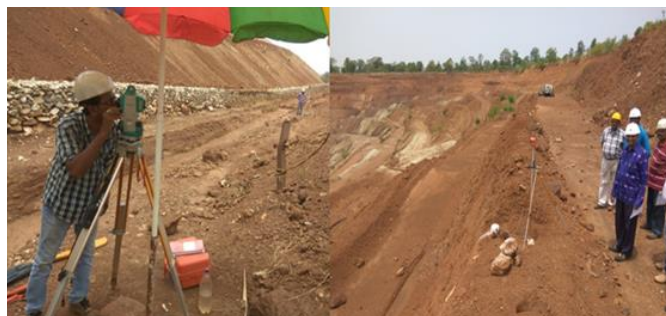
Dump slopes has been monitored with total station and monitoring stations fixed at an interval of 20 to 50 m on the dumps at a distance of about 1m from the crest of the dump slope (Fig 8). The monitoring stations are located at 25m to 50m interval in the zone of interest and on different levels of the dump. Stability of 31 monitoring stations was installed at south dump and 120 stations in the north dump. Some of the monitoring stations i.e.2/1,7/1 and 10/1 in south is relocated since the formation of bench in progress. The variation in reduced levels and horizontal distance on monthly Basis during April 2017 for south and North dump is graphically represented Figure.9, and 10, respectively. Thirty one monitoring stations are installed and considered for the analysis of stability of south dump. 120 monitoring stations are installed in North dump and 25 monitoring stations along the cross section 3300N were considered for the analysis of the North Dump. These stations are DM – 6, DM – 7, DM - 8 DM - 9/2, DM – 12, DM - 13/1, DM - 14/1 , DM - 15/1, DM - 25/0, DM - 27/1, 25/1, 25/5, 25/6, 25/7/1, 25/8/1, 25/9/2, 25/10/2, 25/11/1, 25/13, 25/14, 25/15/1, 25/37, 25/38/1, 25/50. The Monitoring stations are surveyed with reference to the base station associated with a reference station. The movement of each station is calculated with comparison to the initial reading.

**Fig 8: Monitoring of Dump slopes with total station at typical Chromite Mine**

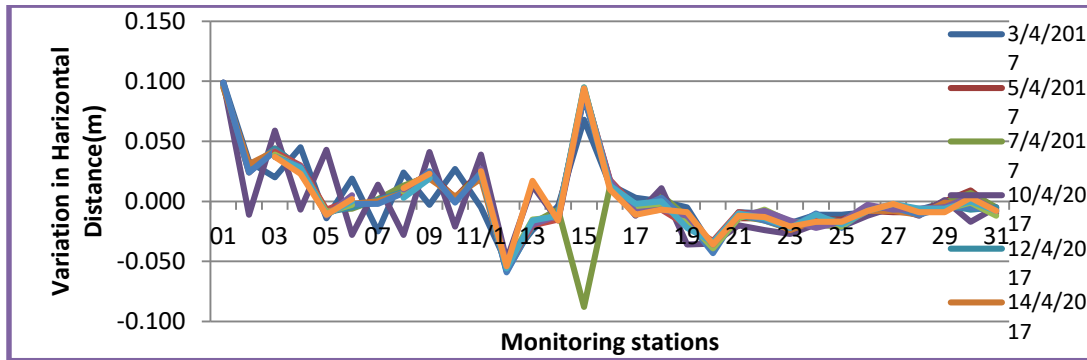
**Fig.9. Variation of horizontal distance at south dump during the 3/4/17 to 28/4/17**

In South dump, maximum displacement observed in horizontal direction is 126 mm and in RLs is 140 mm. At station # 2, and #12-15 displacements are comparatively more during Jan-Apr'17, thereafter these target points recorded no perceptible movements or any consistent increasing trend at these stations. However, during May'17, stations # 5 to 9, and 19 to 24 recorded comparatively more displacements. The target station #2 (171 m RL) is located at the bottom bench, and # 12-15 (174 m RL) on northern side slope of the South dump while # 19-24 are located on Southern side slope of the South dump. Although the movements in both vertical and horizontal directions are recorded by Total station, there is no consistently increasing rate of movements at the stations. Consistently increasing rate of movements at the stations with more than 25 mm/day on more number of stations in any zone of the dump may indicate probability of mass failure of slope. Therefore, for those stations with such excessive displacements, it is recommended to regularly produce up-to-date and accurate dump geometry **on daily basis** for the profile near the target points showing more than 100 mm cumulative displacement, or if feasible a system for continuous monitoring of displacements may be used.

In South dump, maximum change in horizontal distance during January, February, March, April and May'17 was 0.052, 0.077, 0.126, 0.100 and 0.034 m, while for the corresponding period, change in RL is 0.098, 0.117, 0.131, 0.14 and 0.086 m, respectively. Except at few points, there is no consistent increase in cumulative displacement or rate of movement with erratic movements of increasing/decreasing trends at different time period indicating possibility of instrument error or local failure/disturbance of the station by external causes such as moving HEMM. Part of these changes may also be attributed to instrumental and/or personal error because the accuracy of the instrument is  $\pm 5$ mm. Visual observations indicated few cracks of about 10 mm width for a length of about 1.5 m near target station #18-19 during end April'17, without any further growth or widening of cracks on south dump, while no perceptible disturbance in North dump. The above observations revealed practically considerable displacement in south dump. However, some of the local movements observed from the Total Station reading may be attributed to high moisture content of materials and deployment of HEMM near to the monitoring stations for the formation of benches in south dump.

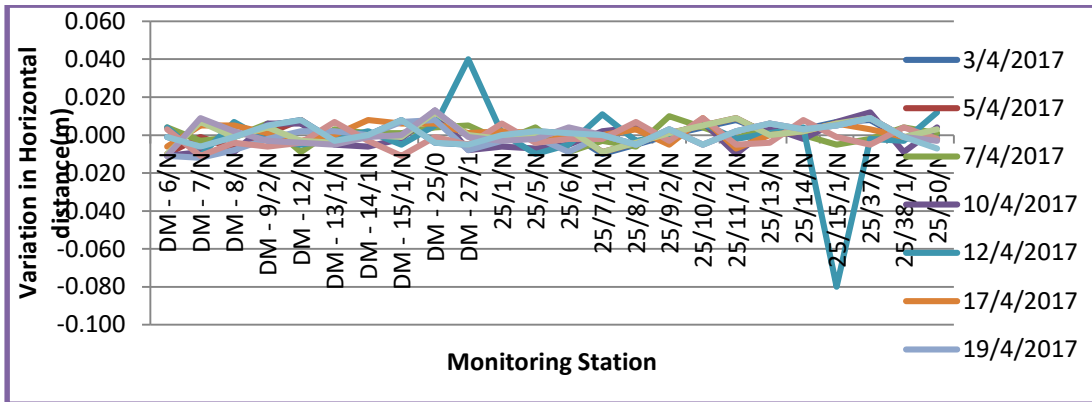
**Fig.10. Variation of horizontal distance at North dump during the 3/4/17 to 26/4/17**

In North dump, maximum change in horizontal distance for North dump during March, April and May'17 was 0.014, 0.013, and 0.012 m, while for the corresponding period, change in RL is 0.017, 0.014, and 0.019, respectively. Maximum displacement observed in horizontal direction is 14 mm and in RLs is 19 mm. Part of these changes may also be attributed to instrumental and/or personal error because the accuracy of the instrument is  $\pm 5\text{mm}$ .
