# **An assessment of mechanical behaviour and fractography study of glass/epoxy composites at different temperatures and loading speeds**

**Sanghamitra Sethi and Bankim Chandra Ray•**

Department of Metallurgical and Materials Engineering, National Institute of Technology  
Rourkela – 769008, India  
•[bcray@nitrkl.ac.in](mailto:bcray@nitrkl.ac.in)  
Phone No: 0661-2462559, 246-2552

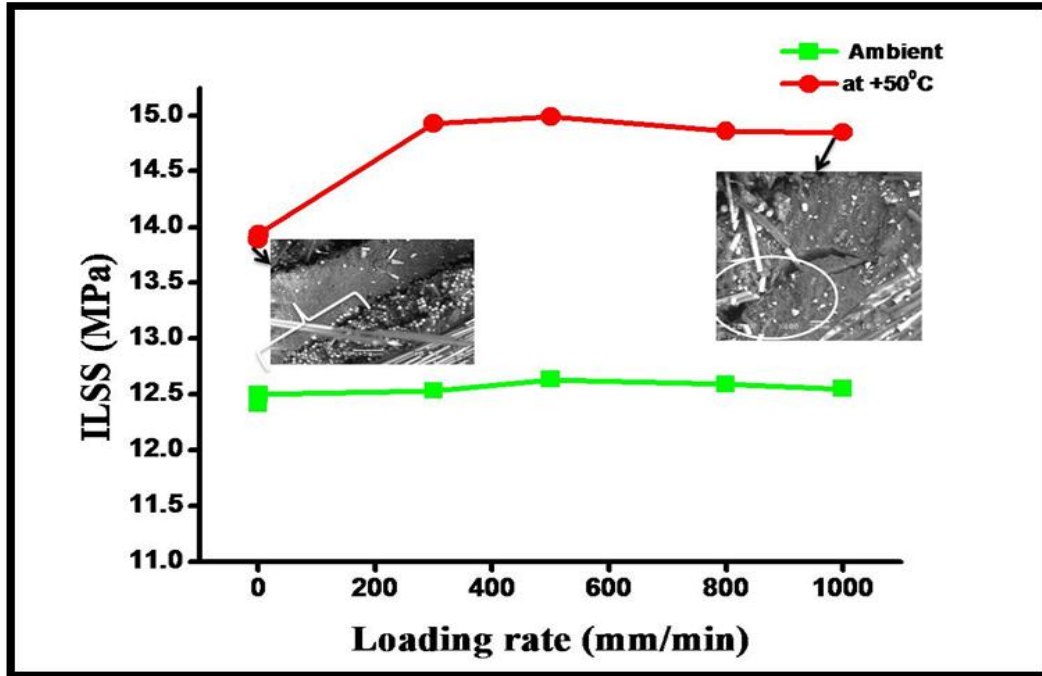
Fig 3(a) Loading rate with ILSS of GFRP samples at +50°C and +28°C temperatures.

Fig 3(a) represents the short beam shear test curves based on different loading rates. The ILSS vs. crosshead speed curves gives different ILSS values at different speed of loading. It was found that ILSS values depend on working temperature of the material. Here we considered 3 modes of loading phase while correlating with interlaminar shear strength, Mode A (1 to 500) mm/min, Mode B (500 to 1000) mm/min and Mode C (0.01 to 1000) mm/min. When the specimen at ambient subjected to 3-point bend test the ILSS values increases with increasing with loading rate in each loading phase. In contrast to this, when the specimen treated with +50°C temperature, the strength had decreases in each modes of loading speed but the ILSS value is more than ambient temperature. In Mode A, it decreases by 16.14% (Max.), Mode B 9.75% (Max) and Mode C 6.05%(Max) was observed. This may be due to spreading of process zone (PZ) in large depth (softer resin) in epoxy resin matrix resin which leads to increase in degree of fiber bridging. In this condition, fiber/matrix debonding is critical and also exhibit increased

deformation which shown in Fig 3 at low and high loading rates. When sample is loaded there is widespread microscopic damage arises throughout the laminate. Large damage can be sustained to a critical value at which failure occurs by the propagation of cracks. These cracks are much more complex in nature than cracks in homogeneous materials. The failure of a composite involves the fractures of the load-bearing fibers and the matrix as well as a complex combination of cracks propagated along the interfaces [15]. Thus ILSS values decreases in every mode of loading.

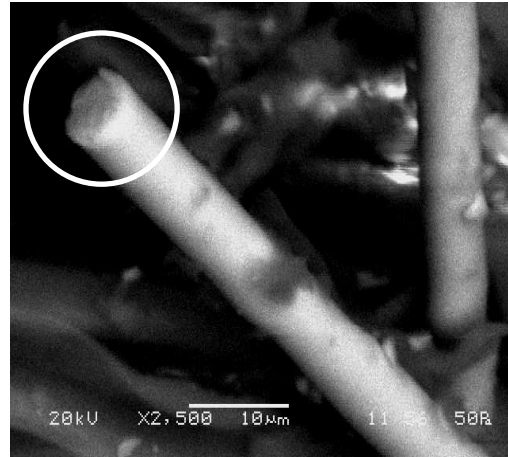
-50°C temperature degree 1 mm/min

800 mm/min

**Fig 4:** Matrix micro cracking and brittle fracture of fiber at -50°C temperature at 1 mm/min and 800 mm/min.

The failed specimen surfaces were viewed under SEM to study how changing failure modes affect the ILSS value as loading rate increased. Identification of the cause of fracture through fractography has become a standard investigation technique. The large depth of focus and the fact that the actual surface can be examined make the SEM, an important tool for research and for failure analysis. Microscopic material failure is defined in terms of crack propagation and initiation. Such methodologies are useful for gaining insight in the cracking of specimens and sample structures under well-defined global load distributions [17]. Microscopic failure considers the initiation and propagation of a crack. Fig (4, 5, 6, and 7) shows impact fracture surfaces of the prepreg composites from which progressive changes in the locus of failure can be clearly identified as a result of change in test temperature for a given loading condition. Fig (4) shows uniform propagation of matrix microcracking at -50°C temperature. The locus of failure is not exactly at the interface region but is significantly above it. However, there is some fiber imprint are visible on the surface. This is because of development of internal residual tensile stresses in the matrix resin at low temperature. As matrix behaves as brittle manner at low temperature the molecular motion will be abysmal; molecular motion will be small and re-orientation modes will be relatively simple [18]. Similarly the deportment of interface region of glass/epoxy at low temperature doesn't undergo any significant change which tends to high adhesion bond strength. Thus very tiny interfacial failure observed at low loading speed (Mode

A). Here cohesive failure of the bulk matrix plays the dominant role. At higher crosshead speed 800mm/min brittle failure of fiber observed. Brittle fibers have low fracture strain and low energy absorbing capability [19]. Fibers can fracture early at the weak cross section point, which is not necessarily the direction of crack propagation.

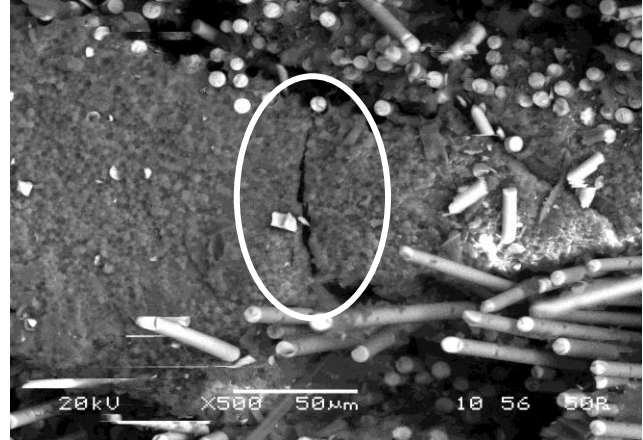
Ambient 1 mm/min

Ambient 800 mm/min

**Fig 6:** Scanning electron micrograph at ambient 1 mm/min and 800 mm/min shows steps and welts as well as matrix cracking respectively.

In contrast to the foregoing phenomena, fracture surface of ambient samples subjected to 1 mm/min, 800 mm/min and 1000 mm/min was shown in Fig (6) display fiber pull-out, steps and welts, tiny nodules on the matrix surface, matrix cracking, and progressive interfacial debonding. In addition, there are significant changes in the morphology of the matrix fracture. Besides that, other important matrix fracture is scraps and ribbons. When multiple microcracks are formed and begin to propagate in several planes, and they subsequently converge onto one plane. Ambient

temperature signifies the beginning of the steps and welts as well as macromatrix cracking. Both the things are parallel to the fracture propagation direction. This failure mode was observed at low loading speed. The steps are identified by toughened matrix or smooth region, while welts are identified by ribbons. If the crack planes overlap before they coalesce to form scarp [22]. When the loading rate increases 800 mm/min density of crack plane increases and macomatrix cracking plays the dominant role.

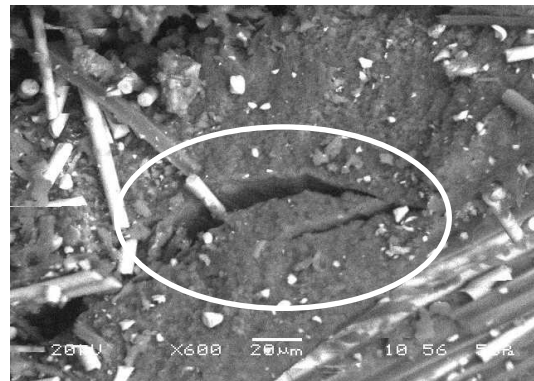
+50°C temperature 1mm/min

800mm/min

**Fig 7:** Thermal conditioning sample at 1 mm/min and 800 mm/min showing fibre/matrix debonding and macromatrix cracking.

Fig (7) shows fiber/matrix debonding as well as cohesive failure of matrix at low and high loading rate respectively at +50° C temperatures. Damage initiation for cohesive failure observed at the matrix resin where severity of stress state occurred.
