# CORROSION BEHAVIOUR OF FRICTION-STIR WELDED DISSIMILAR ALUMINUM ALLOY BUTT JOINTS

**Abstract:** This paper presents the effect of process variables on micro structure and corrosion behavior of heat affected zone in friction stir welded AA5052H32-AA6061t6 aluminum plates. As friction stir welding process operates at well below the melting temperatures of base metals, often the grain structure is not much affected. This may lead to poor corrosion behavior in some instances. Some methods to improve corrosion resistance are proposed in this paper for dissimilar aluminum alloy joints. Initially, the experimental procedure is explained and output parameter measurement tests are given. Tensile and impact tests are also conducted along with microscopic examination of samples. The weld velocity and tool rotation are varied in three levels and some set of samples are prepared. Microscopic examination of samples using SEM revealed that the accumulated copper at the nugget zone in all the cases is cause of corrosion behavior of samples.

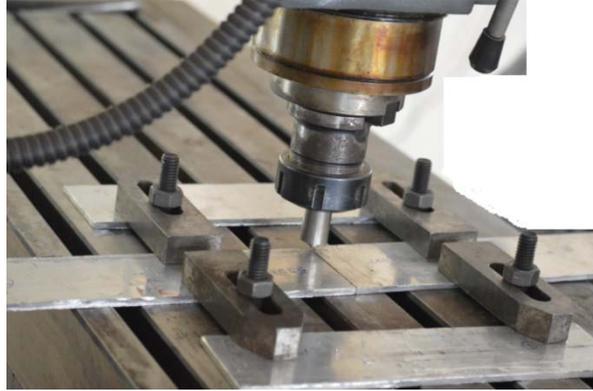
A column and knee type vertical milling machine is used for joining operation. In all the experiments, AA6061T6 was kept on the advancing side. The weld speeds are taken as 18, 22 and 25 mm/min, while the tool rotations are taken as 760 rpm, 1130 rpm and 1340 rpm based on the availability over the machine. Fig.1 shows the experimental set-up.

Fig.1. Experimental arrangement on vertical milling machine

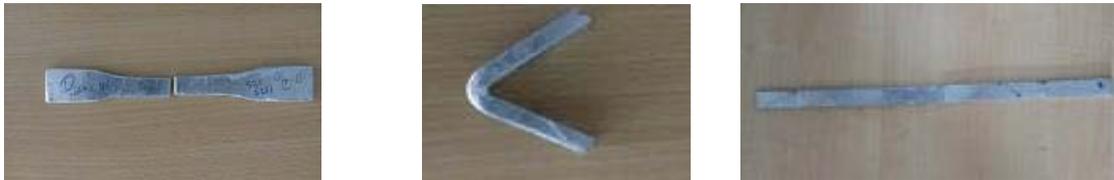
Tensile, impact and hardness tests are conducted respectively on 100 tonne Instron machine, Charpy machine and Rockwell hardness tester. The samples prepared from cross-section of weld are shown in Fig.2

Fig.2. Test samples in one condition (22 mm/min, 760 rpm, 2.2 mm depth)
