# EVALUATION OF STABILITY OF DUMP SLOPES THROUGH OBSERVATIONAL AND NUMERICAL MODEL APPROACH – CASE STUDY

## ABSTRACT

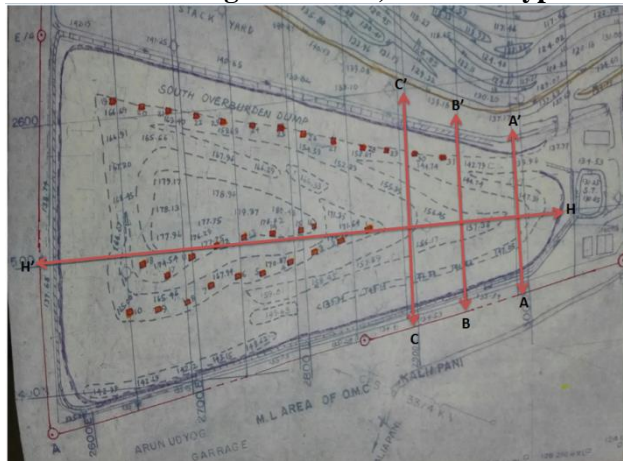
**Fig. 2. Plan view of the South dump in a typical chromite mine**

In South dump, maximum displacement observed in horizontal direction is 126 mm and in RLs is 140 mm. At station # 2, and #12-15 displacements are comparatively more during Jan-Apr'17, thereafter these target points recorded no perceptible movements or any consistent increasing trend at these stations. However, during May'17, stations # 5 to 9, and 19 to 24 recorded comparatively more displacements. The target station #2 (171 m RL) is located at the bottom bench, and # 12-15 (174 m RL) on northern side slope of the South dump while # 19-24 are located on Southern side slope of the South dump. Although the movements in both vertical and horizontal directions are recorded by Total station, there is no consistently increasing rate of movements at the stations. Consistently increasing rate of movements at the stations with more than 25 mm/day on more number of stations in any zone of the dump may indicate probability of mass failure of slope. Therefore, for those stations with such excessive displacements, it is recommended to regularly produce up-to-date and accurate dump geometry **on daily basis** for the profile near the target points showing more than 100 mm cumulative displacement, or if feasible a system for continuous monitoring of displacements may be used.

In South dump, maximum change in horizontal distance during January, February, March, April and May'17 was 0.052, 0.077, 0.126, 0.100 and 0.034 m, while for the corresponding period, change in RL is 0.098, 0.117, 0.131, 0.14 and 0.086 m, respectively. Except at few points, there is no consistent increase in cumulative displacement or rate of movement with erratic movements of increasing/decreasing trends at different time period indicating possibility of instrument error or local failure/disturbance of the station by external causes such as moving HEMM. Part of these changes may also be attributed to instrumental and/or personal error because the accuracy of the instrument is  $\pm 5$ mm. Visual observations indicated few cracks of about 10 mm width for a length of about 1.5 m near target station #18-19 during end April'17, without any further growth or widening of cracks on south dump, while no perceptible disturbance in North dump. The above observations revealed practically considerable displacement in south dump. However, some of the local movements observed from the Total Station reading may be attributed to high moisture content of materials and deployment of HEMM near to the monitoring stations for the formation of benches in south dump.

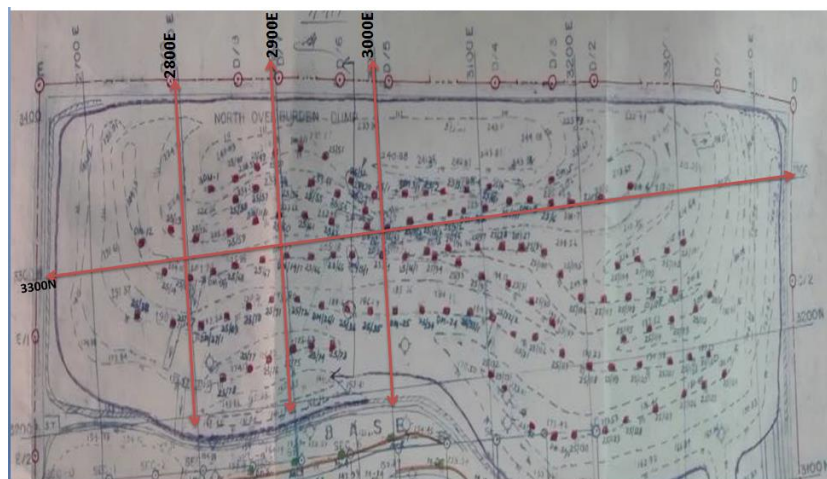
**Fig. 3. Plan view of the North dump in a typical chromite mine**

In North dump, maximum change in horizontal distance for North dump during March, April and May'17 was 0.014, 0.013, and 0.012 m, while for the corresponding period, change in RL is 0.017, 0.014, and 0.019, respectively. Maximum displacement observed in horizontal direction is 14 mm and in RLs is 19 mm. Part of these changes may also be attributed to instrumental and/or personal error because the accuracy of the instrument is  $\pm 5\text{mm}$ .
